1. AGENCY USE ONLY (Leave Blank)		2. REPORT DATE October 1991		3. REPORT TYPE AND DATES COVERED Interim	
4. TITLE AND SUBTITLE Human Factors Assessment of USCG				5. FUNDING NUMBERS 69X0243

6. AUTHOR(S) LCDR F. D. Holcombe, MSC, USN and LT S. C. Webb, MSC, USNR					
7. PERFORMING ORGANIZATION NAME(S) AND ADDRESS(ES) Naval Biodynamics Laboratory P. O. Box 29407 New Orleans, LA 70189-0407				8. PERFORMING ORGANIZATION REPORT NUMBER NBDL-91R003

13. ABSTRACT (Maximum 200 words) Part I documents the ergonomic and safety deficiencies noted during an on-site familiarization and inspection of the prototype 47-ft motor lifeboat. The following human factors operability and habitability problem areas are addressed: steps, platforms, and railings; doors hatches, and passageways; controls; instruments and displays; workspace; and habitability considerations. Approaches to problems are indicated in the form of suggestions for possible redesign, reconfiguration, relocation, or replacement of equipment. Deficiencies fall into these categories: design of ladders; design and configuration of hatches; location and arrangement of controls, instruments, and displays; design of seating; and workspace

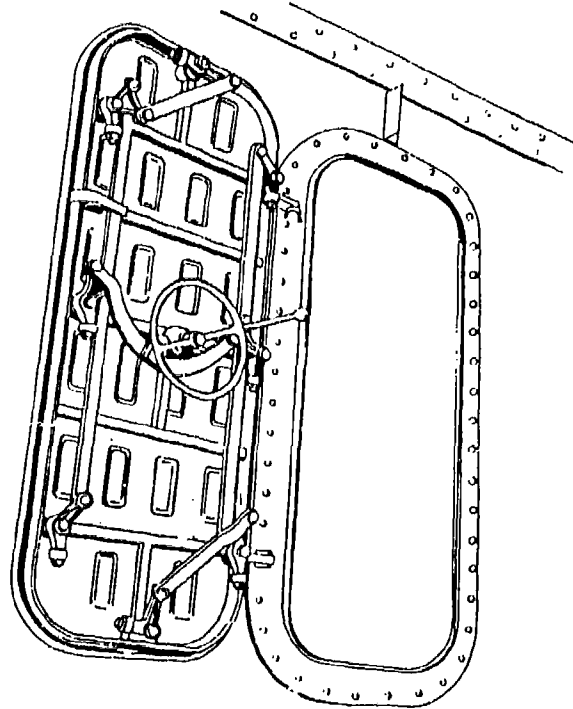
- The door impedes the movement of the port OB chair.
 - The bolts of the door are exposed and present a hazard to the crew passing through the door. Crewmembers have reported minor injuries due to these bolts.

Figure I.3. Watertight door with control wheel, extended handle, and dogs.

- Approach:**
- The door should be designed with a self-locking mechanism to secure the door in an open position. This mechanism is recommended for all doors.

- Grab handles should be placed over the doors and on both sides of the door.
 - Additional positive control of the door can be gained by installing a handhold/grip on both sides. Currently, crewmembers are required to open the door and hold it open (with the dog handle) while climbing up the ladder.

- Recess, cap, or remove threads from the end of the bolts to eliminate the workspace hazard.

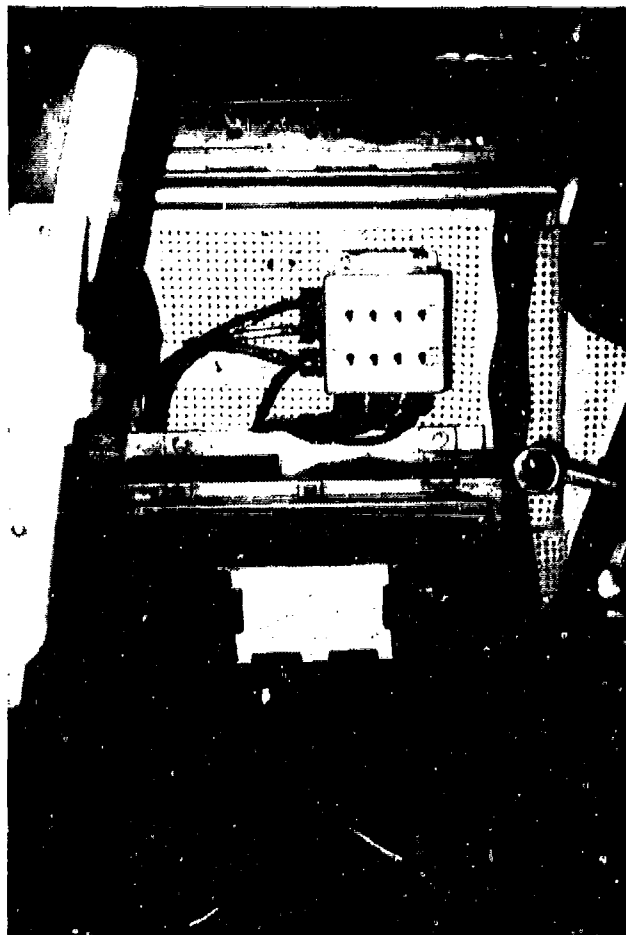
Figure II.13. 12 volt DC panel starboard bulkhead of enclosed bridge and starboard jump seat.

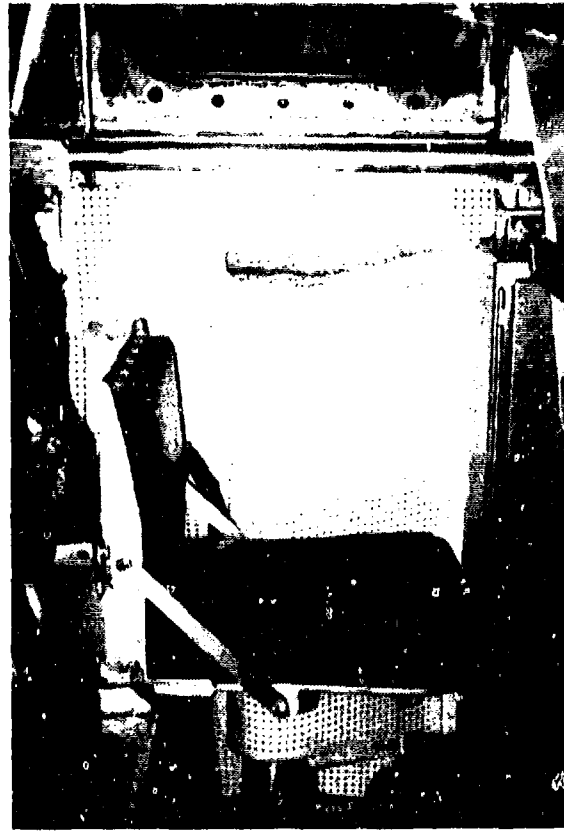
Figure II.14b. Portside jump seat and shore tie.

- Relocate the shore tie closer to the beam of the boat. This arrangement would eliminate the need for the port bulkhead protrusion into the enclosed bridge (see Figure II.14) and would increase crew workspace (habitability).

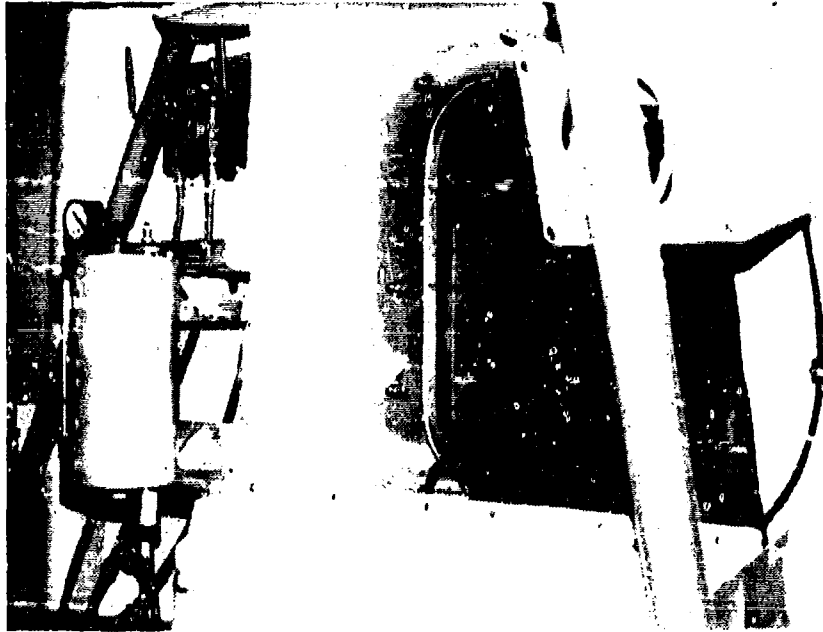
Figure II.15. Aft window of the enclosed bridge battle lantern and hydraulic fluid reservoir.

- Replace the heating ventilation and air conditioning unit with a more compact unit (see discussion below).
- Relocate the battle lantern that is located on the aft bulkhead of the enclosed bridge (see Figure II.15). It is located underneath the port railing of the ladder and poses a minor handling hazard to crew climbing the ladder. The current hydraulic fluid reservoir location is an alternate location (see hydraulic fluid reservoir discussion below).

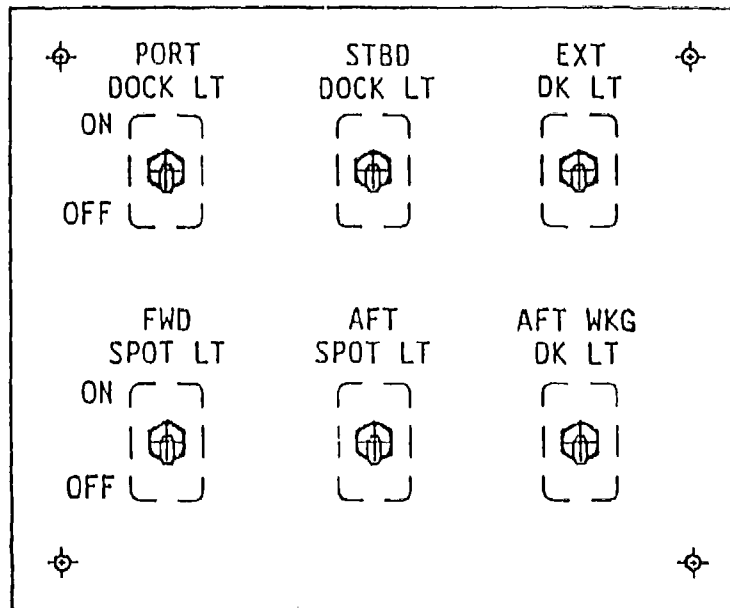
Figure II.24a. Current navigation and lighting switch panels on open bridge.
